Alabama Home Inspections

Property Inspection Report

1000 Sample Dr., Samletown USA
Inspection prepared for: Report Sample
Inspection Date: 1/21/2010 Time: 400pm Size: Approx. 2,200sf
Weather: Cloudy 62

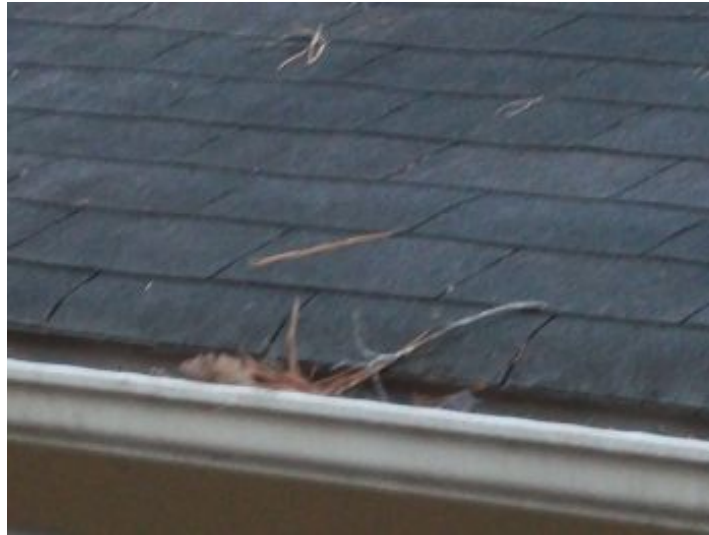
Observations:
 • The gutters are full of debris in areas and needs to be cleaned. The debris in gutters can also conceal rust, deterioration or leaks that are not visible until cleaned, and I am unable to determine if such conditions exist.

Gutters full of debris.

Roofing		
Page 4 Item: 2	Roof Drainage System Condition	<ul style="list-style-type: none"> The gutters are full of debris in areas and needs to be cleaned. The debris in gutters can also conceal rust, deterioration or leaks that are not visible until cleaned, and I am unable to determine if such conditions exist.
Page 5 Item: 3	Flashing Condition	<ul style="list-style-type: none"> There is evidence of repair around the chimney. Recommend Roofing Contractor for further evaluation Repair/Replacement
Exterior		
Page 6 Item: 1	Wall Cladding Condition	<ul style="list-style-type: none"> Areas of the brick veneer needs pointing. Recommend proper professional to Repair/Replace
Page 6 Item: 5	Vegetation, Grading, and Drainage Condition	<ul style="list-style-type: none"> There is a negative slope toward the residence, this can cause or contribute to water intrusion or deterioration. I recommend correcting landscape to drain water away from home.

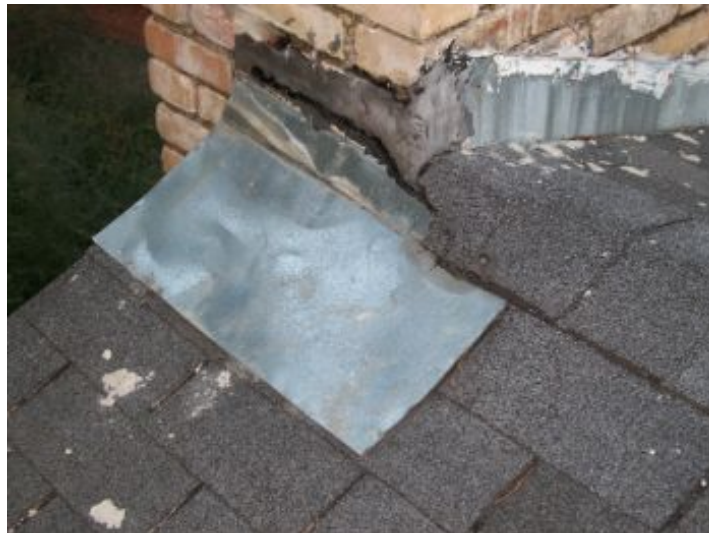
Observations:
 • There is evidence of repair around the chimney. Recommend Roofing Contractor for further evaluation Repair/Replacement

Evidence of repair around the chimney.

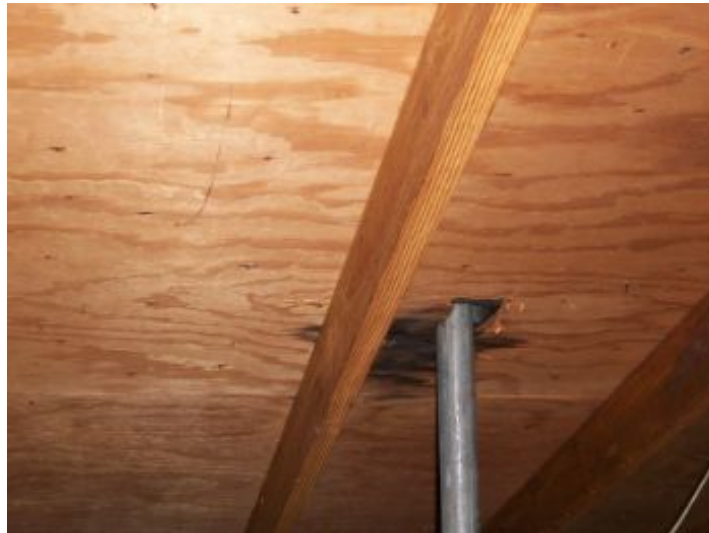
Moisture stain around the vent pipe in the attic.

Materials: Stick Built
 Materials: Gable
 Observations:
 • Moisture stain on roof sheathing around the vent pipe in the attic.
 Recommend roofing contractor evaluate and Repair/Replace.

Interior		
Page 8 Item: 6	Counter Condition	<ul style="list-style-type: none"> Grout needed around tile on bathroom counters. Recommend proper professional for Repair/Replace.
Structural		
Page 10 Item: 6	Roof (Structural) Condition	<ul style="list-style-type: none"> Moisture stain on roof sheathing around the vent pipe in the attic. Recommend roofing contractor evaluate and Repair/Replace.
Plumbing		
Page 11 Item: 1	Drain, Waste, and Vent Condition	<ul style="list-style-type: none"> Toilet loose at the floor in the master bathroom. Recommend plumber Repair/Replace. Toilet loose at the floor in the hall bathroom. Recommend plumber Repair/Replace.
Page 11 Item: 2	Supply and Distribution System Condition	<ul style="list-style-type: none"> There is a supply line leak under the hall bathroom sink. Recommend plumber to Repair/Replace. There is a supply line leak under the sink in the downstairs bathroom. Recommend plumber to Repair/Replace.

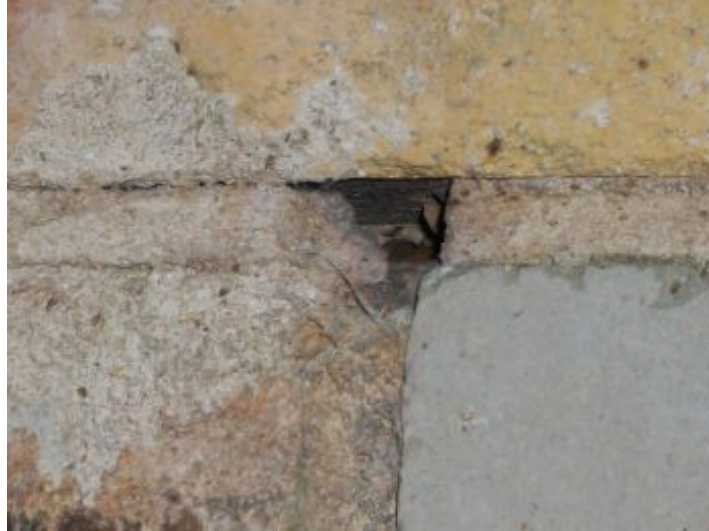
- Areas of the brick veneer needs pointing. Recommend proper professional to Repair/Replace

Areas of the brick veneer needs pointing.

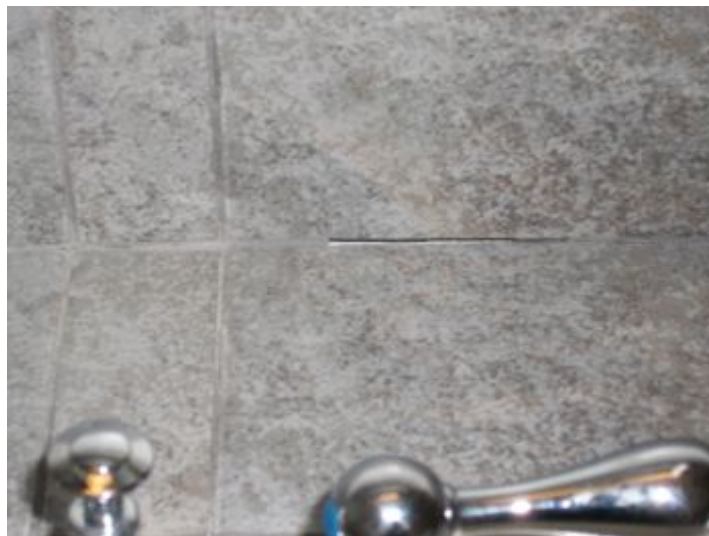
Materials: Laminate • Tile
 Observations:
 • Grout needed around tile on bathroom counters. Recommend proper professional for Repair/Replace.

Tile around the bathroom sinks needs grout.

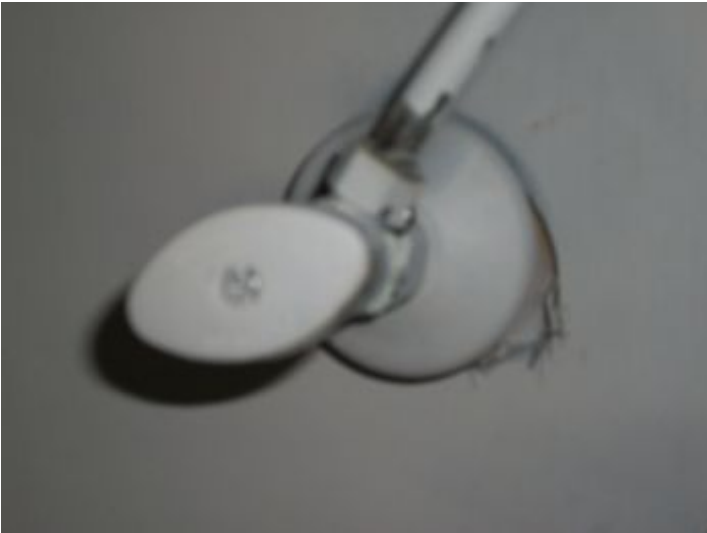
- There is a supply line leak under the hall bathroom sink. Recommend plumber to Repair/Replace.
- There is a supply line leak under the sink in the downstairs bathroom. Recommend plumber to Repair/Replace.

Supply line under hall bathroom sink leaking.

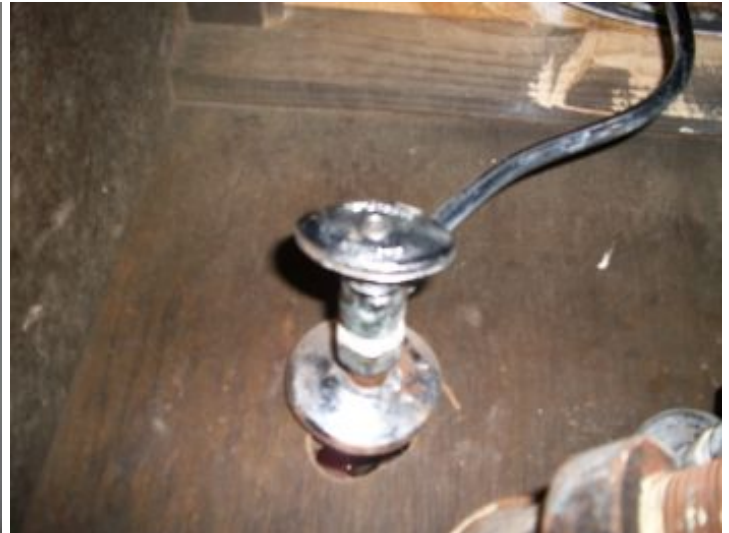
Supply line leak under the downstairs bathroom sink.

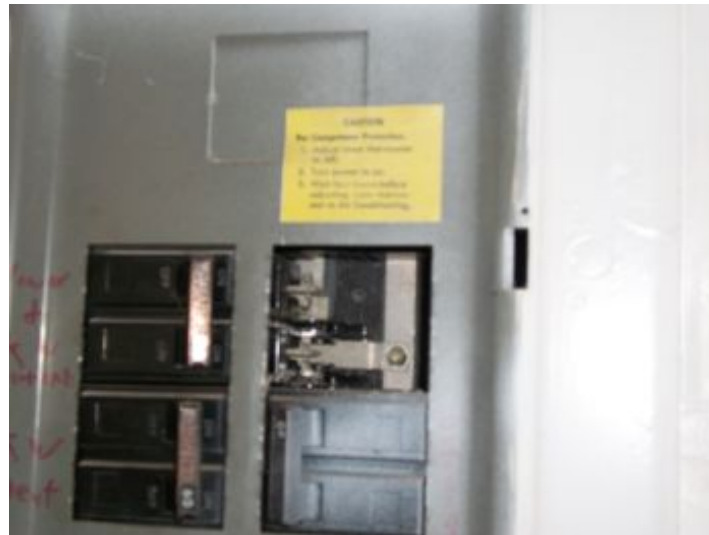
- There are breaker knock outs missing. Recommend Electrician for Repair/Replacement.

Missing Breaker knock out.

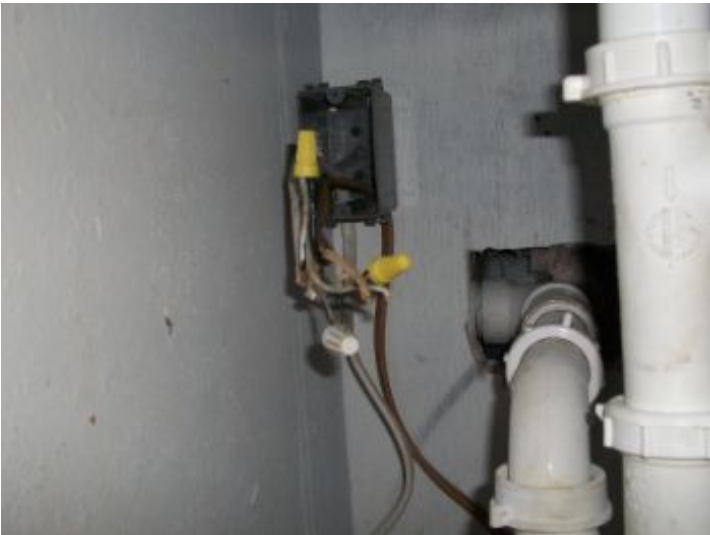
- Junction Box Cover Plates Missing/Damaged. Recommend Electrician for Repair/Replacement.

Junction box missing cover plate under kitchen sink.

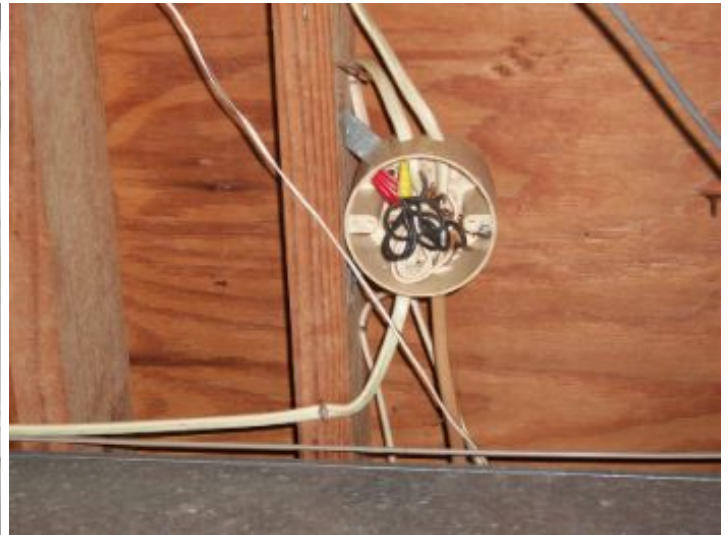
Junction box missing cover plate in garage.

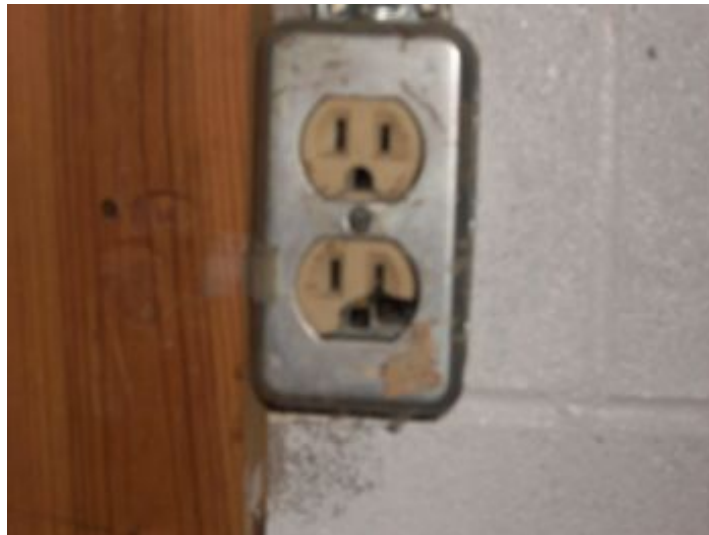
Outlet damaged in garage.
